**Dundee Central Waterfront:
Historic Building Recording**
Data Structure Report

by Louise Turner

issued 28th January 2010

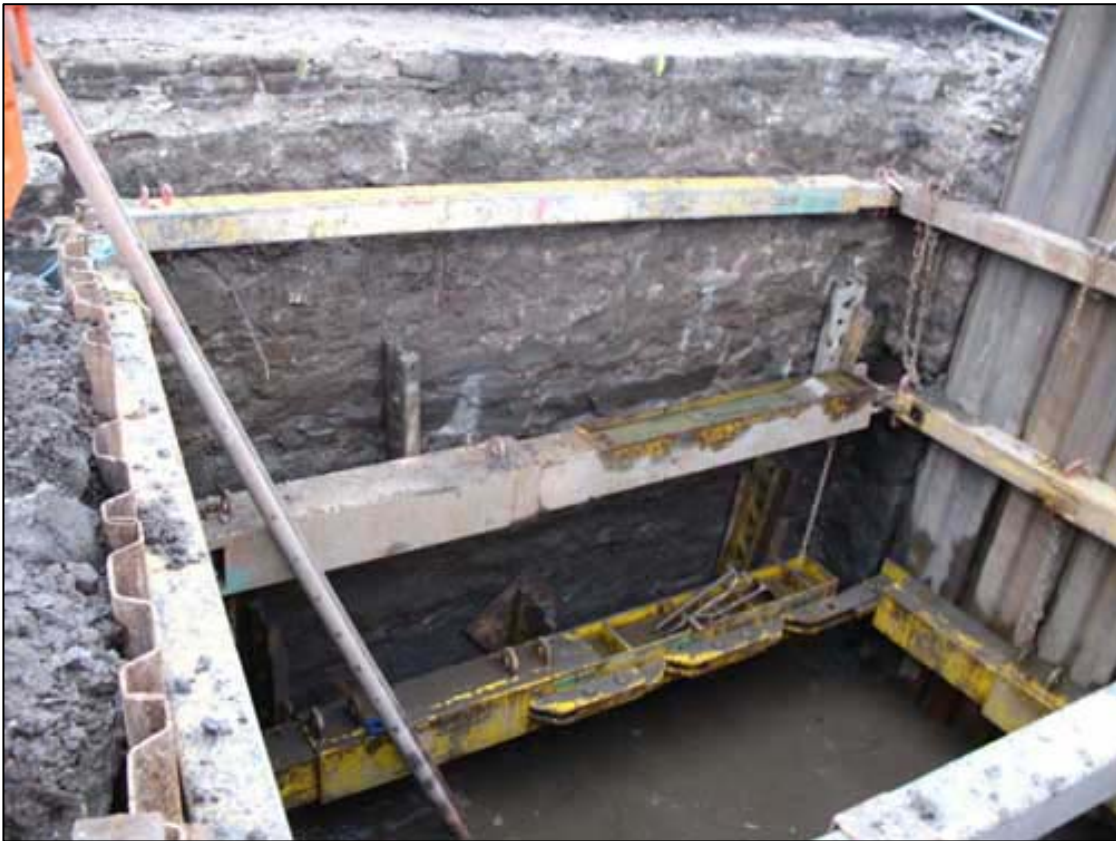
24. The internal face of the SE Wall was also vertical, with no indication of battering (Figure 5a). There was, however, a buttress evident at the SW end of the trench, the extent of which could not be established on account of modern shoring, and *in situ* fill material.

Figure 5a: Inner Face of Outer Harbour Wall, Buttress to Right

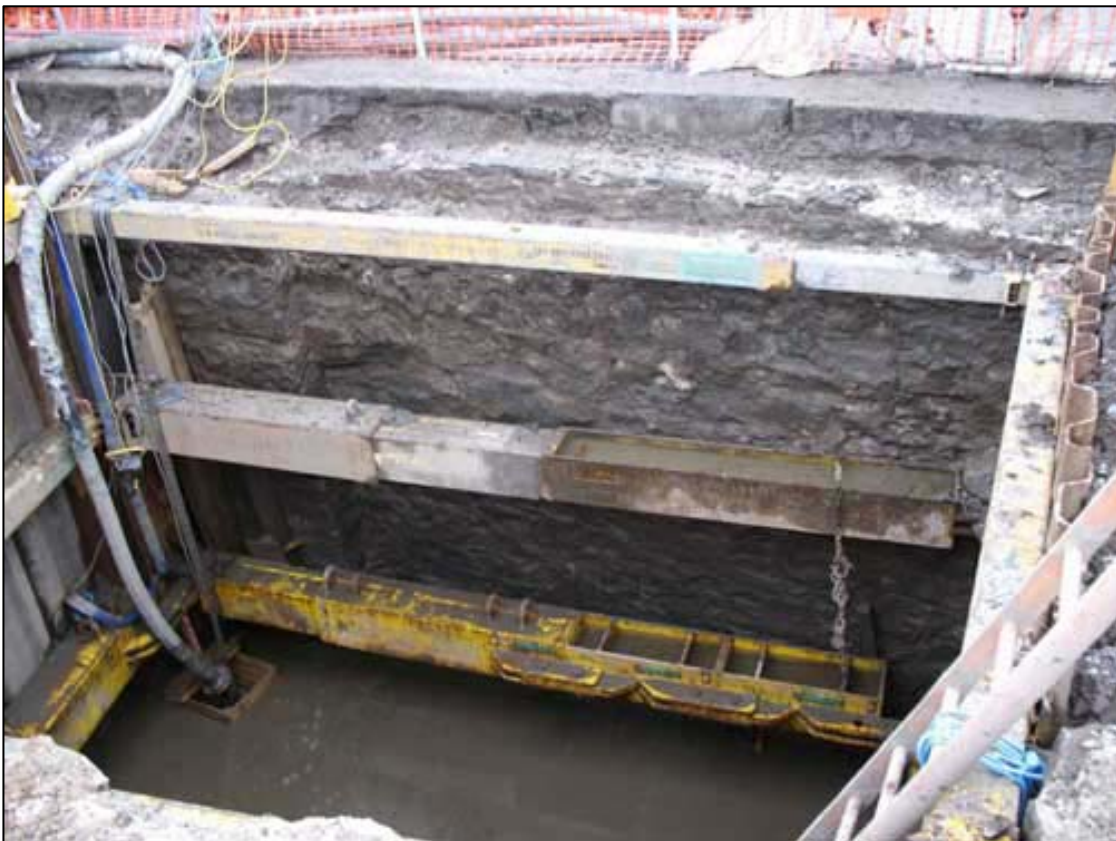
25. Thanks to the excavations that were underway in the former harbour interior, it was possible to study the details of the NW Wall more closely. It measured approximately 1.77m in width, and again, its inner face was vertical, comprised of mortared random rubble (Figure 5b). There was another buttress, a short feature measuring perhaps 0.5m in length (accurate measurements could not be obtained for reasons of Health and Safety). This was slightly offset from the buttress built into the SE wall, rather than being directly opposing.

Figure 5b: Inner Face of Inner Harbour Wall, Buttress to Left

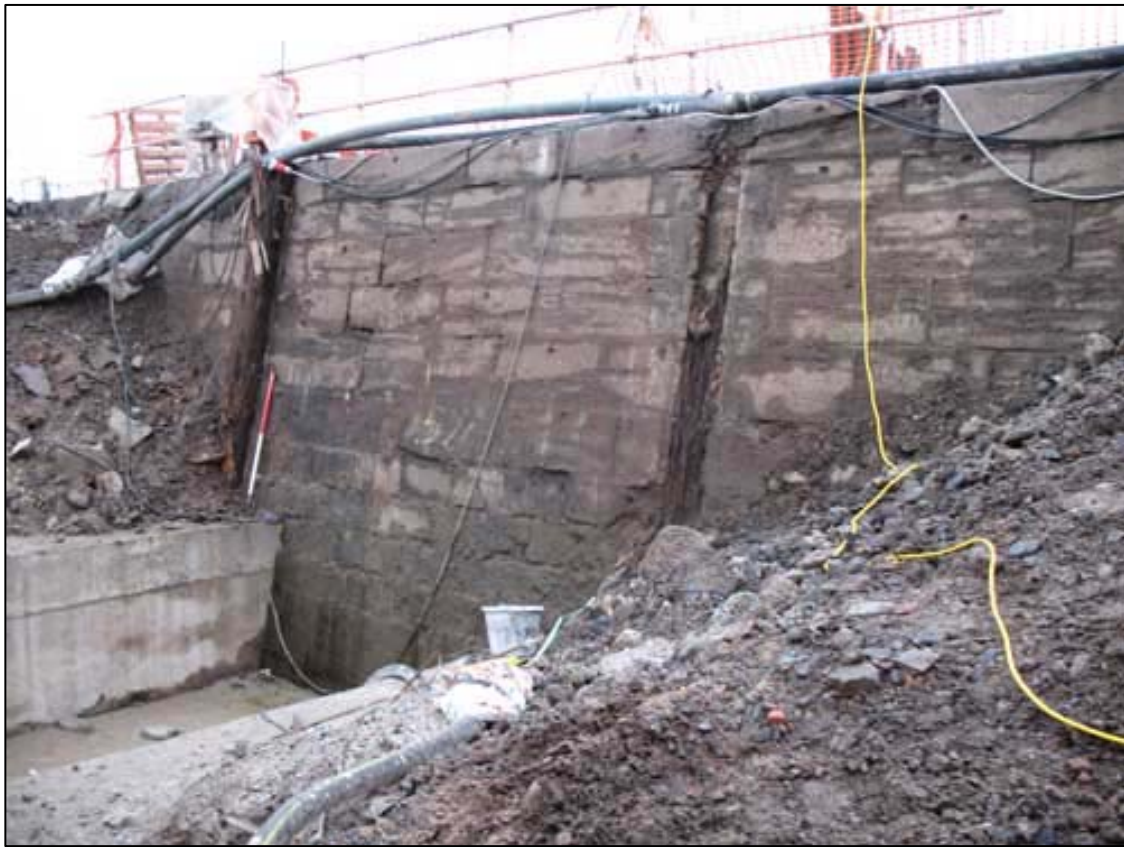
26. The outer face of the NW wall, which would once have formed the inner face of the completed West Protection Wall, proved to be most informative, with several features of interest surviving (Figure 6a). The wall had been exposed to a depth of 4.07m below the original ground surface. It had a marked batter, and was composed of coursed squared rubble blocks measuring up to 1.23m x 0.43m in extent. The material used in its construction was whinstone, and some of its surfaces had been stugged.

Figure 6a: Outer Face of Inner Harbour Wall, With *In Situ* Timber to left

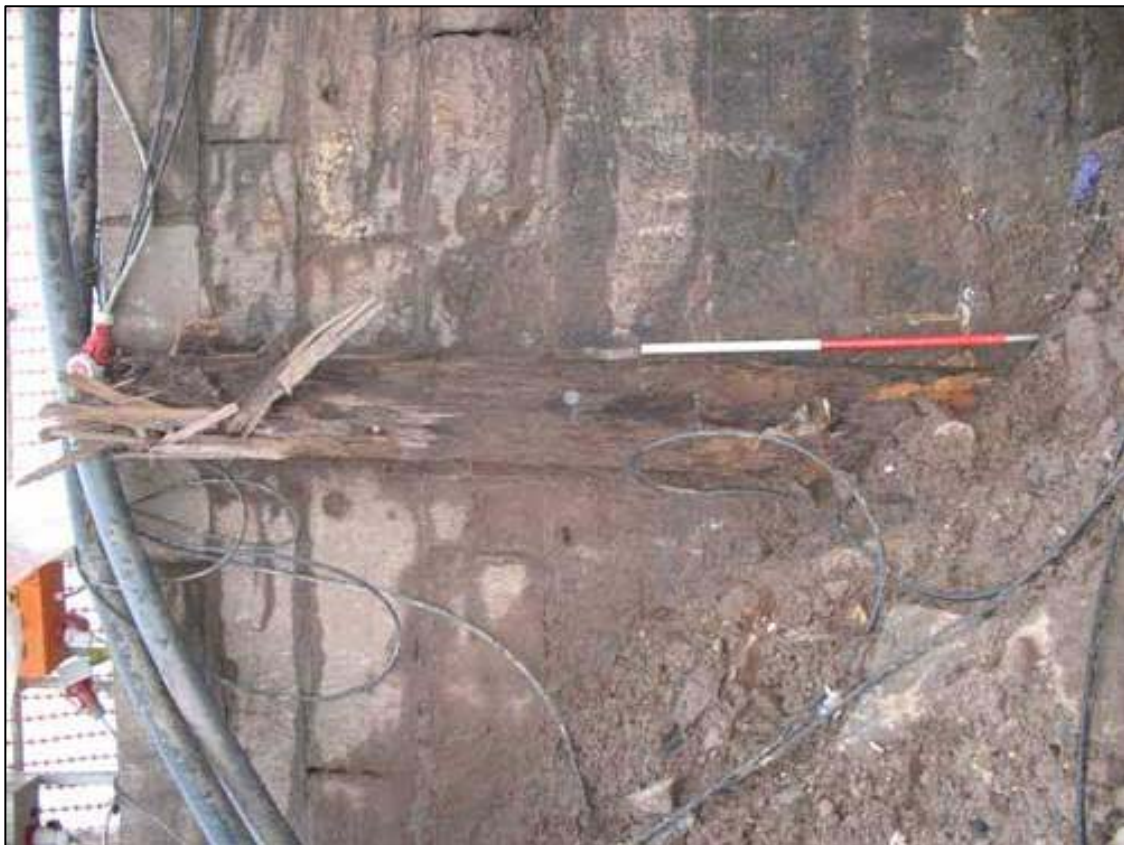
Figure 6b: View of *In Situ* Timber and Detail of Masonry

27. Vertical slots had been carved into the masonry to form sockets for massive timber beams (Figures 6b; Figure 7a) measuring approximately 0.27m wide and 0.37m in thickness. The remains of two such slots were visible in the exposed stretch of walling. In one of these, the timber remained *in situ*, while in the other the wood only survived over roughly half of its extent. The complete timber was of particular interest in that it retained a cast iron mooring ring towards the top (Figure 7b).

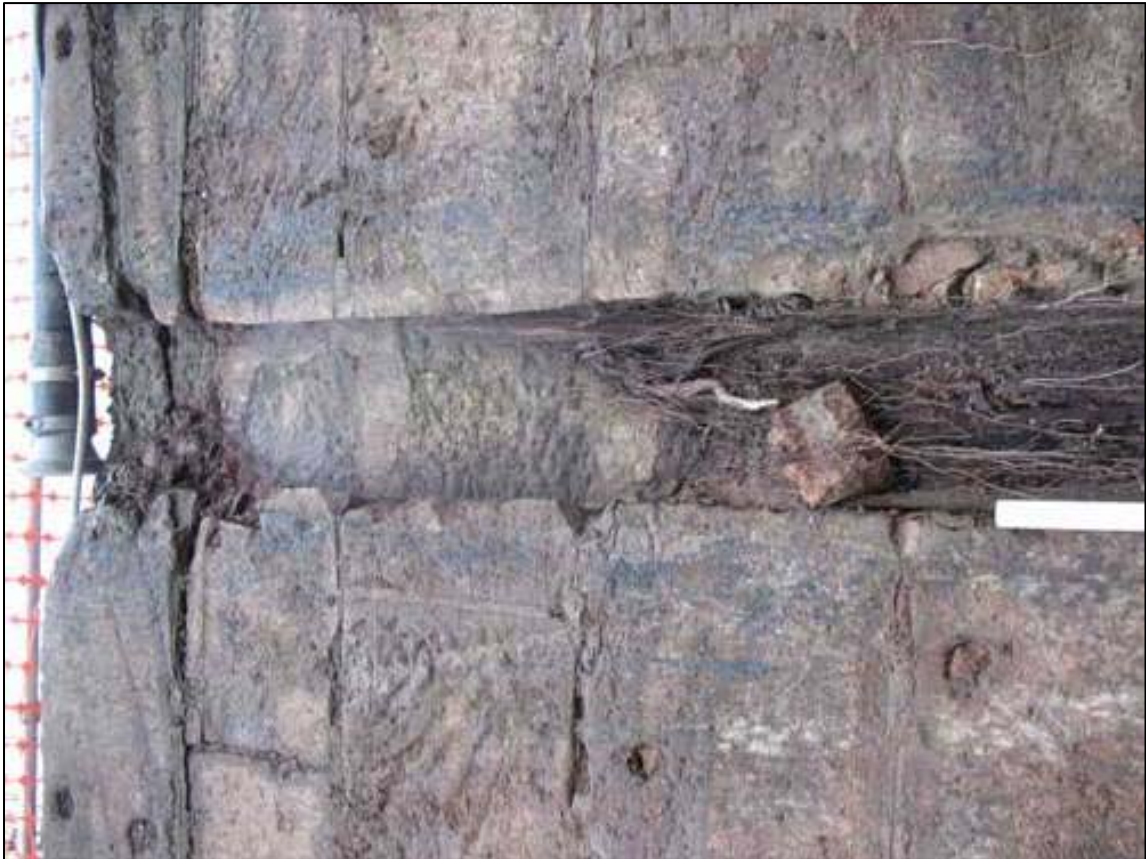
Figure 7a: Detail showing Vertical Slot Cut into Masonry of Outer Face, Inner Wall

32. Of additional interest were the two vertical slots that were revealed in the inner facing wall, the N-Facing elevation. These had been cut into the masonry in order to receive a massive timber beam. This would have functioned as a buffer, allowing ships to be pushed against the harbour walls with the movement of the tide without causing damage to their hulls. Archive photographs show that these timber beams were a recurring feature throughout the harbour, with a particularly complex framework of beams being evident around the entrance to the Earl Grey Dock at the west side of the Tidal Harbour (Figures 8 a and b).

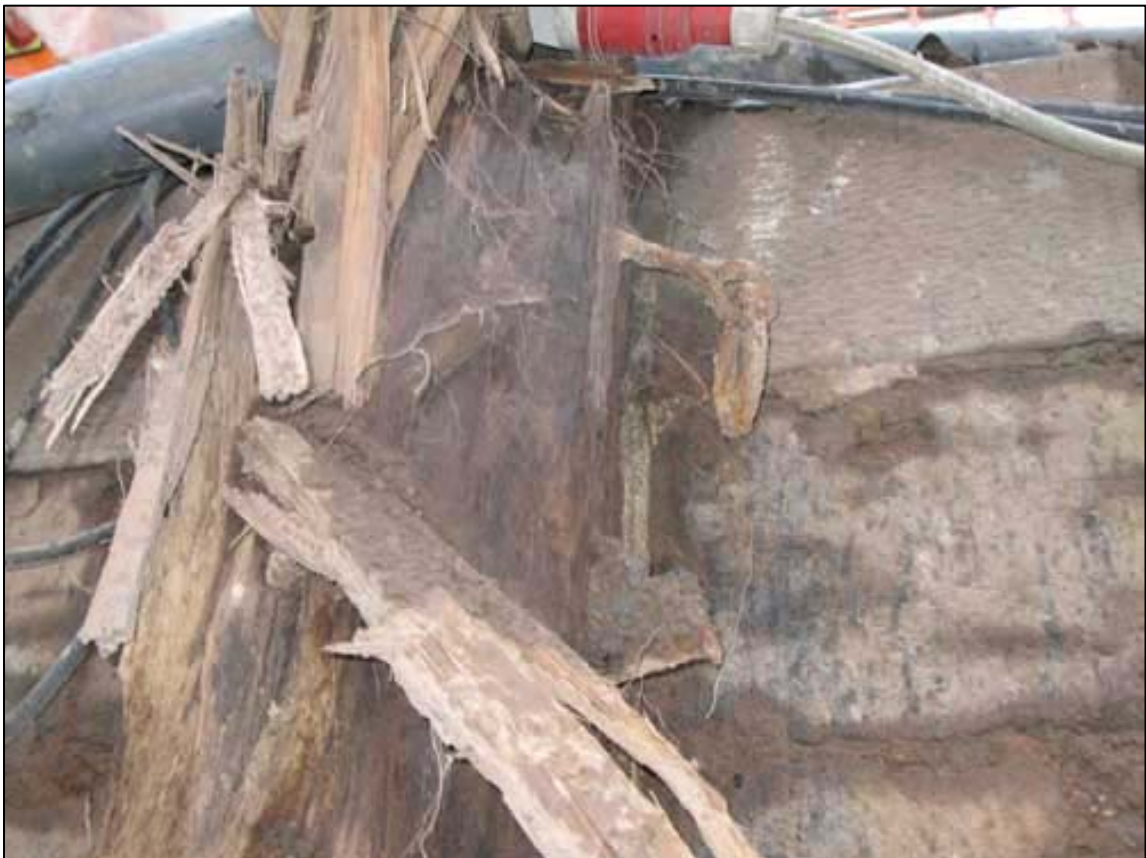
Figure 7b: Detail of Cast Iron Mooring Ring

33. In the exposed section of walling revealed during these works, one beam survived in its entirety, while the other survived in fragmentary form. The complete example was of particular interest, in that it still had an *in situ* mooring ring, located towards the top of the beam.

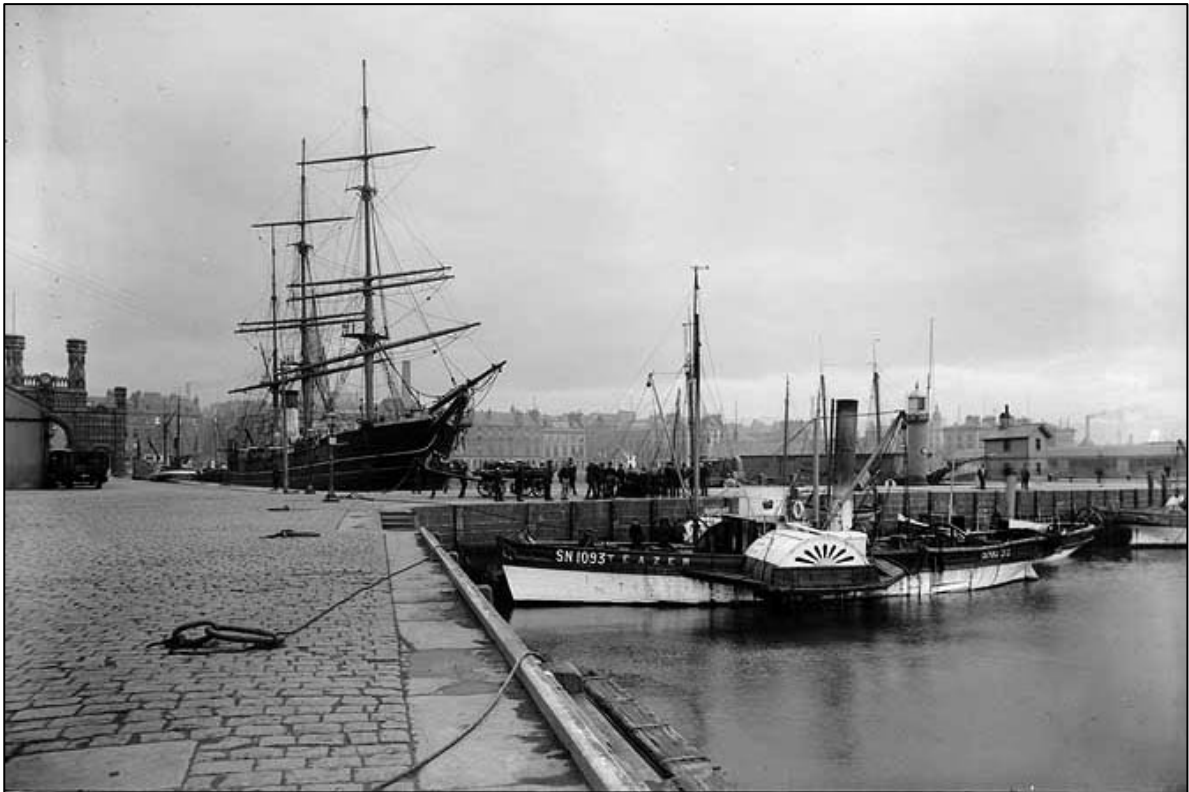
Figure 8a: View of Dundee Docks, showing *in situ* Timber Buffering (Wilson, 1895a)

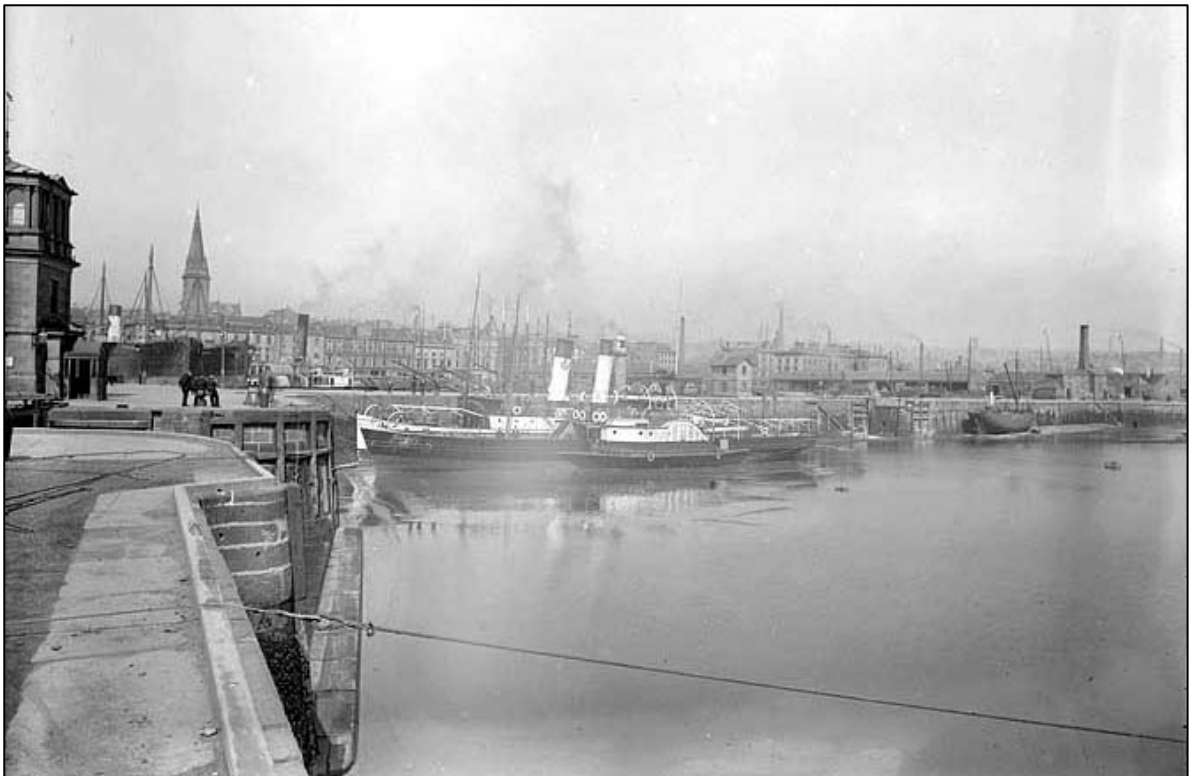
Figure 8b: View of the Tide Harbour, with Timber Buffering at Entrance to Earl Grey Docks (Wilson, 1895b)
